Progress 48P Undocking, Qualify

Progress 48P Undocking, Quantify in COL

Acceleration Measurements Program

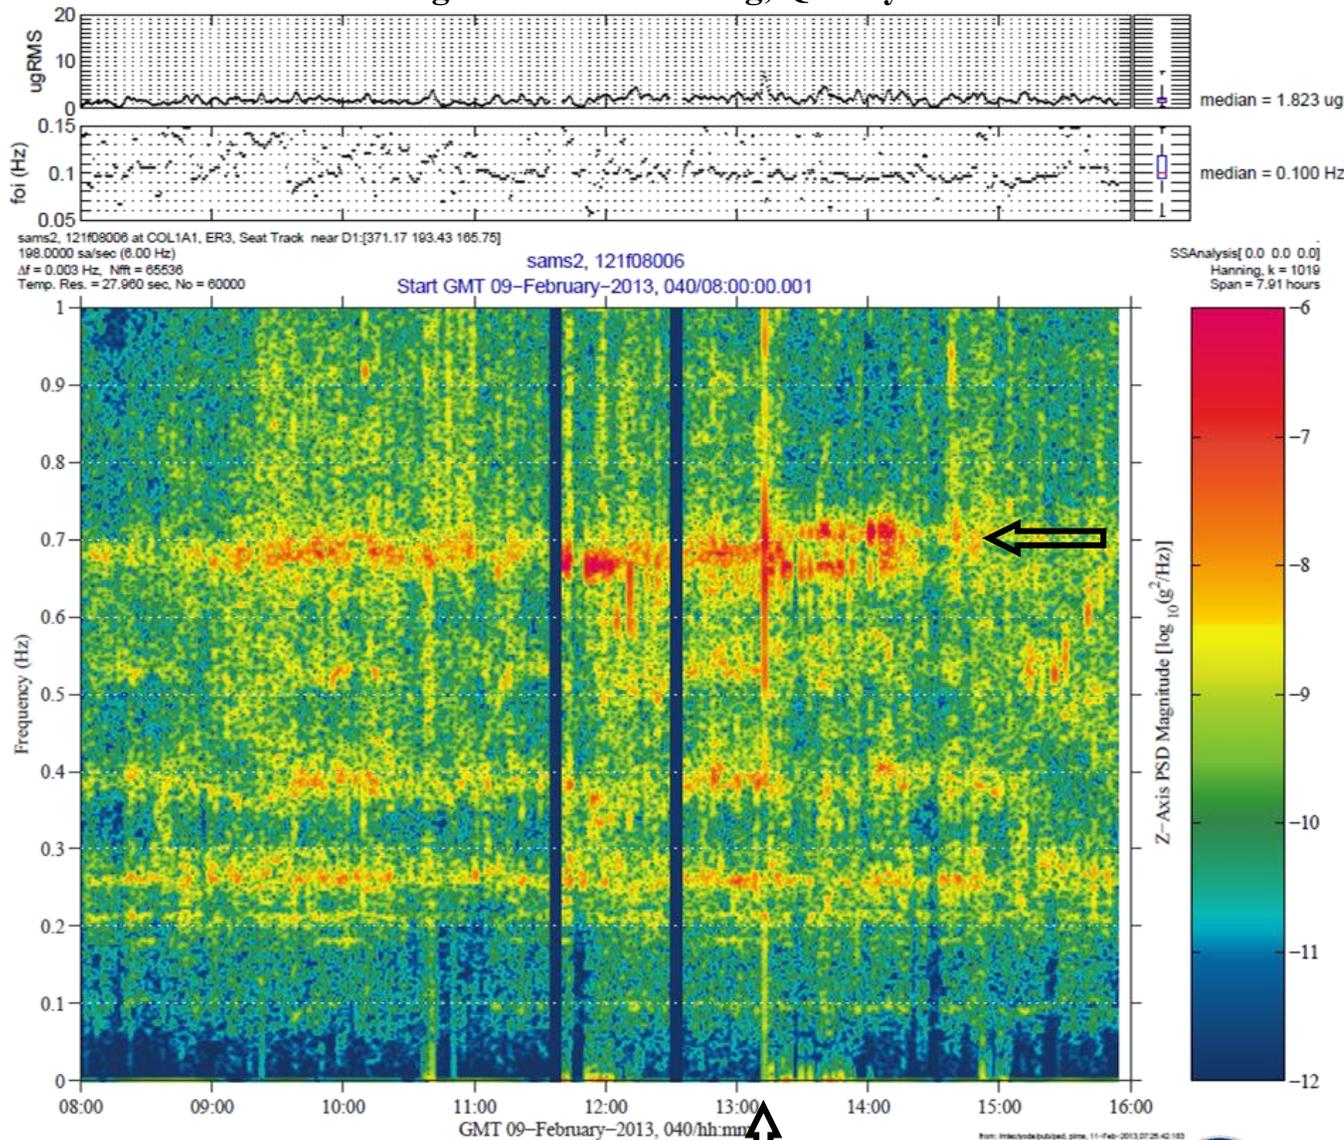
Description	
Sensor	121f08 198 sa/sec (6 Hz)
Location	COL1A1, ER3, Seat Track
Plot Type	spectrogram

- The MER console log shows “the Progress 48P vehicle successfully undocked from the ISS Russian Segment Docking Compartment 1 docking port at GMT 40/13:15:22 after the command to open the vehicle hooks was issued at 40/13:12:30”. **Note:** the MER console log's undocking time was about 15 seconds before SAMS recorded an impulse event in all 3 labs, these acceleration measurements show that the event actually took place closer to about GMT 13:15:37.
- Note from the black arrows on this spectrogram that the undocking event caused a noticeable impulse at undock time with ringing at about 0.7 Hz after the event.

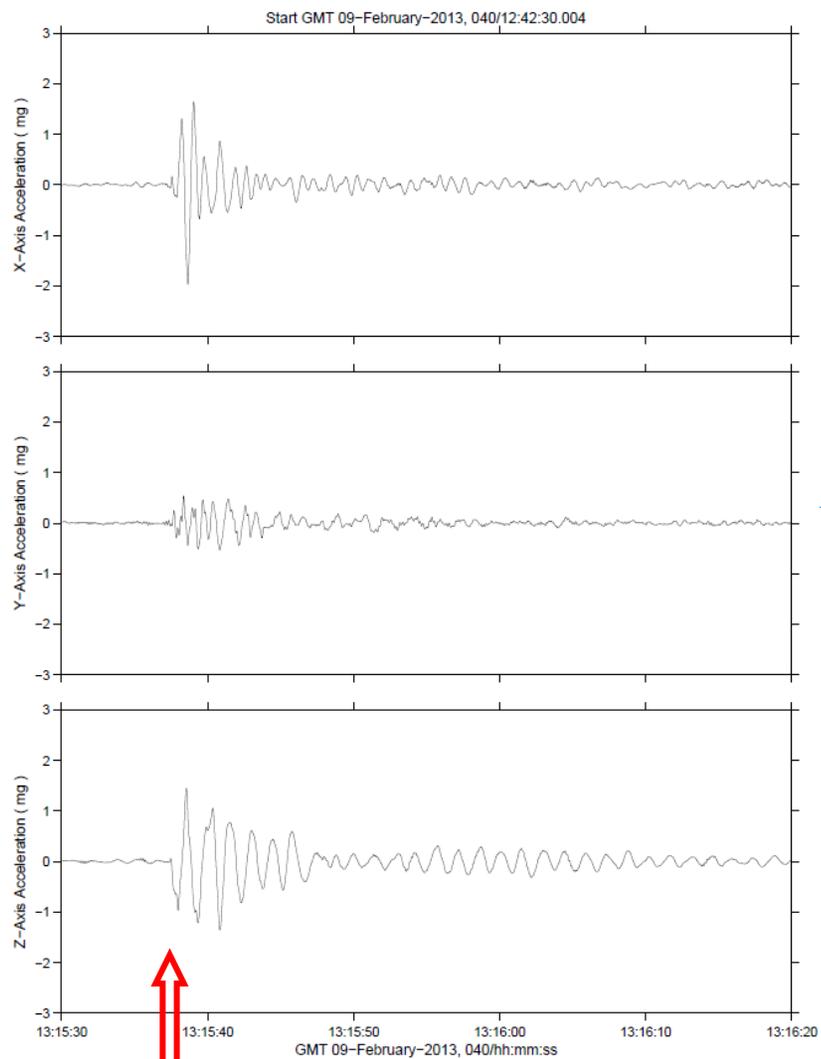
sams2, 121f08006 at COL1A1, ER3, Seat Track near D1:[371.17 193.43 166.75]
 198.0000 sa/sec (6.00 Hz) SAMS2, 121f08006, COL1A1, ER3, Seat Track near D1, 6.0 Hz (198.0 s/sec) SSAnalysis[0.0 0.0 0.0]

Description	
Sensor	121f08 198 sa/sec (6 Hz)
Location	COL1A1, ER3, Seat Track
Plot Type	acceleration vs. time

- The impulsive disturbance from the undocking event was registered with vector magnitude acceleration as follows in the 3 labs (up to 6 Hz):

Sensor (LAB)	a (mg)
121f03 (USL)	1.93
121f05 (JEM)	1.88
121f08 (COL)	2.26

- Note from the 3 subplots on this page (one each for the X-, Y-, and Z-axis) that the Y-axis registered as the smallest component. This was true to varying degrees for all 3 labs.

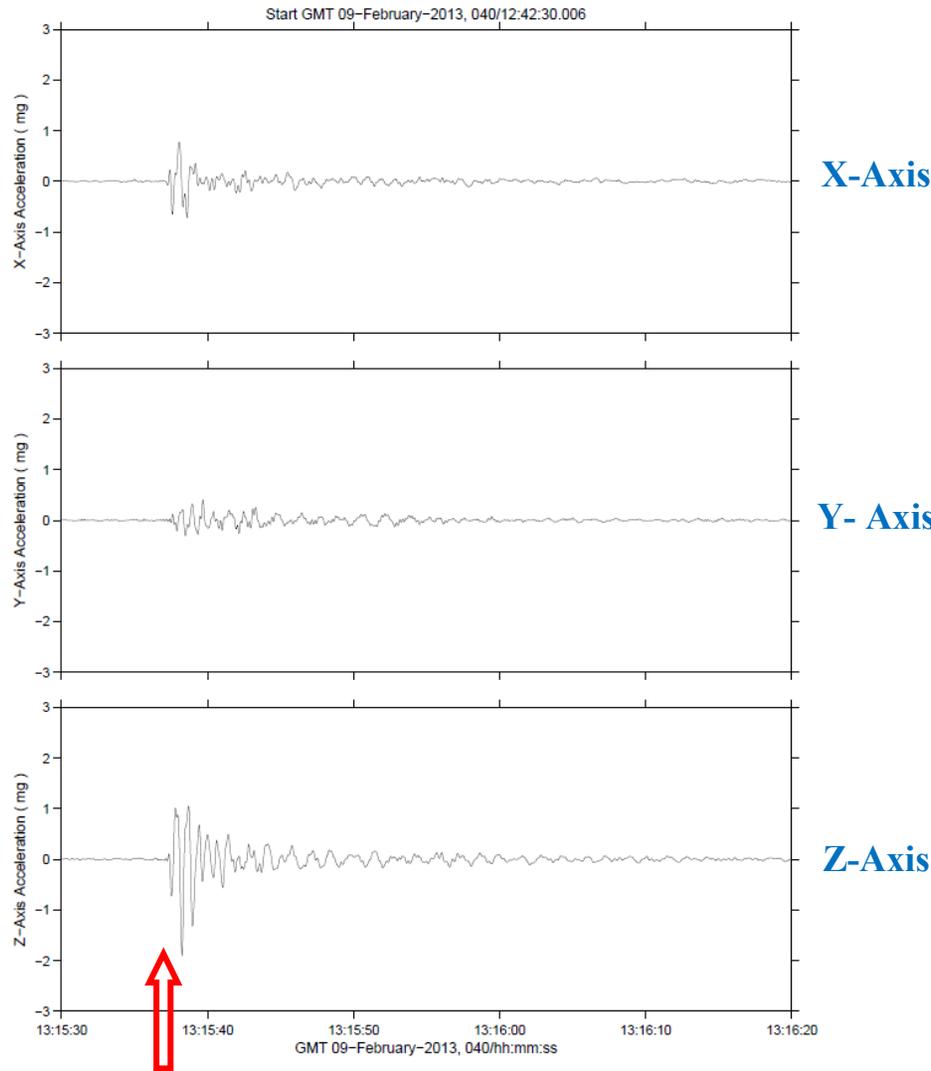
Progress 48P Undocking, Quantify in USL

sams2, 121f03006 at LAB101, ER2, Lower Z Panel [191.54 ~40.54 135.25]
 142.0000 sa/sec (6.00 Hz) SAMS2, 121f03006, LAB101, ER2, Lower Z Panel, 6.0 Hz (142.0 s/sec) SSAnalysis[0.0 0.0 0.0]

Description	
Sensor	121f03 142 sa/sec (6 Hz)
Location	LAB101, ER2, Lower Z Panel
Plot Type	acceleration vs. time

- The impulsive disturbance from the undocking event was registered with vector magnitude acceleration as follows in the 3 labs (**up to 6 Hz**):

Sensor (LAB)	a (mg)
121f03 (USL)	1.93
121f05 (JEM)	1.88
121f08 (COL)	2.26

- Note from the 3 subplots on this page (one each for the X-, Y-, and Z-axis) that the Y-axis registered as the smallest component. This was true to varying degrees for all 3 labs.

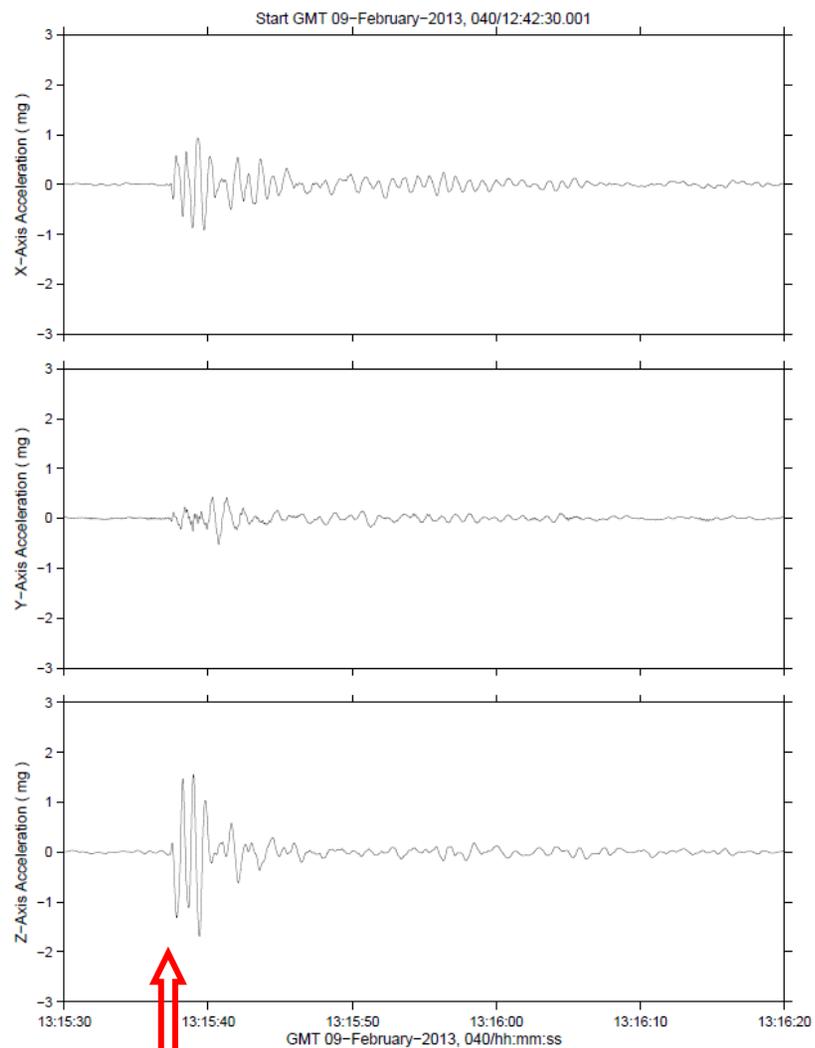
Progress 48P Undocking, Quantify in JEM

sams2, 121f05006 at JPM1F5, ER4, Drawer 2 [466.80 -292.06 214.56]
 142.0000 sa/sec (6.00 Hz) SAMS2, 121f05006, JPM1F5, ER4, Drawer 2, 6.0 Hz (142.0 s/sec) SSAnalysis[0.0 0.0 0.0]

Description	
Sensor	121f05 142 sa/sec (6 Hz)
Location	JPM1F5, ER4, Drawer
Plot Type	acceleration vs. time

- The impulsive disturbance from the undocking event was registered with vector magnitude acceleration as follows in the 3 labs (**up to 6 Hz**):

Sensor (LAB)	a (mg)
121f03 (USL)	1.93
121f05 (JEM)	1.88
121f08 (COL)	2.26

- Note from the 3 subplots on this page (one each for the X-, Y-, and Z-axis) that the Y-axis registered as the smallest component. This was true to varying degrees for all 3 labs.

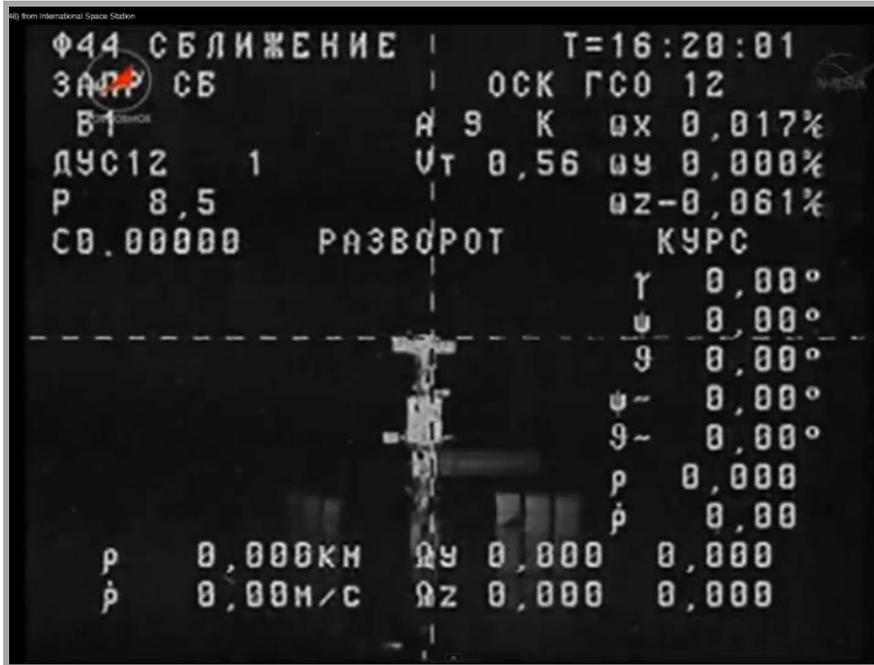
- Progress is an unmanned Russian re-supply vehicle. After undocking, the vehicle's trajectory will cause it to burn up due to friction from the Earth's atmosphere.
- The figure to the left is a screenshot that shows a view of the ISS from the Progress 48P as it departs.
- The image below shows spacecraft when it first approached the ISS.
